Progress report on Douglas Mk V

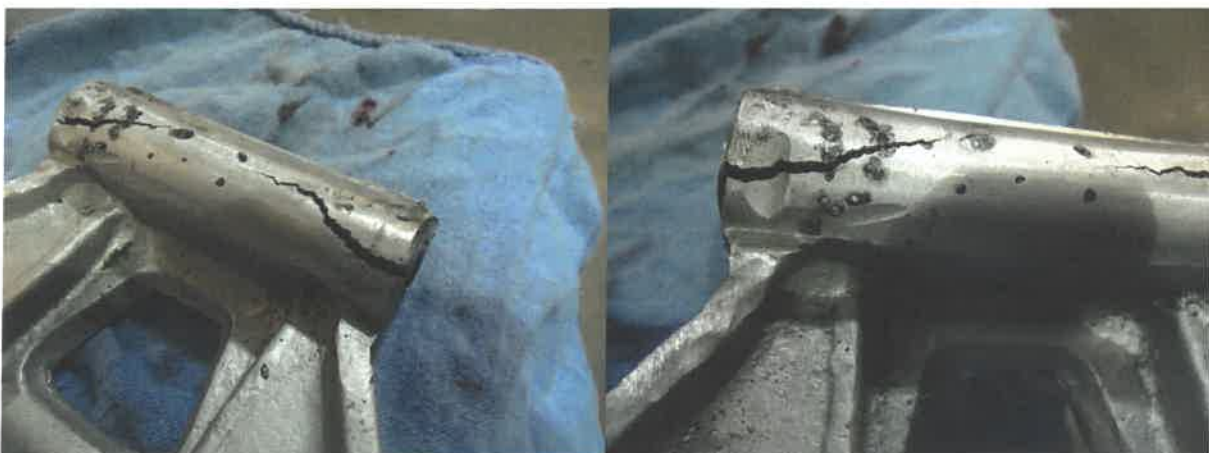
The suspension and headstock were greased and we then turned our attention to the stand. With the machine on the bench it was easier to see the nature of the problem, which was caused by wear in the aluminium casting of the stand and also the stand brackets on the frame. To give us access to the stand and the frame brackets, the petrol tank, seat, engine and gearbox were removed. When we came to examine the stand we found that it was cracked, almost to the point of failing altogether, across the pivot section, please see photographs attached. The strength of the stand had been compromised by the addition of a $\frac{5}{8}$ " outside diameter tube in an attempt to take up the wear in the pivot. This had left insufficient aluminium in the pivot area, leading to the cracking. This could not be repaired by simply welding it back together again, a new pivot section would have to be made and welded to the stand. The stud through the centre of the tube had also been increased in size to $\frac{1}{2}$ " from $\frac{3}{8}$ ". A new $\frac{1}{2}$ " diameter pivot tube was made along with a new $\frac{3}{8}$ " clamping stud. The stand pivot lugs on the frame were built up with M.I.G. weld and shaped in situ to suit the stand stops. Two new top-hat bushes were made for the frame lugs to restore the $\frac{3}{8}$ " diameter for the stud. Having made the new stand pivot boss, we fitted the stand in the mill and milled off the old boss. The stand was then milled to the same profile as the new pivot boss, which we tacked into place to enable us to check that it was in the correct place relative to the feet. On finding that it was, we welded the pivot boss into place and dressed the joint. The stand was then refitted.

The damaged stand. ↑

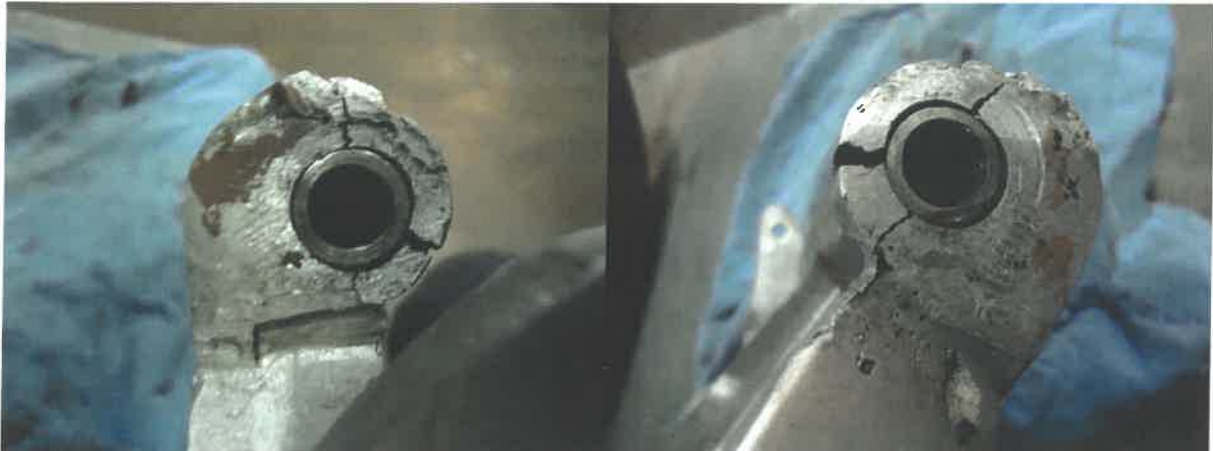
The damaged stand. ↑
